Steering Solutions

Story and Photos by Mike Drew

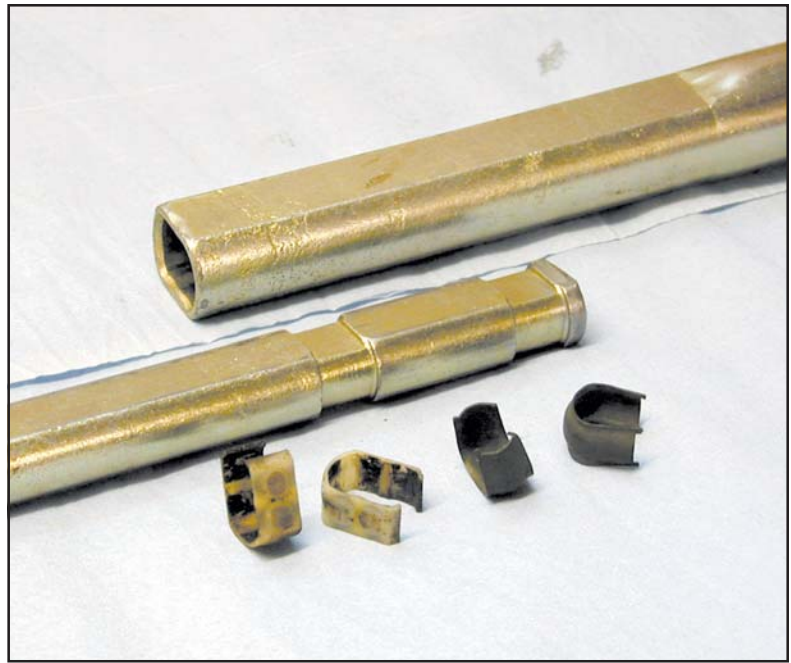
raised humps attached to the male portion, which are designed to be a press-fit inside the female portion. Unfortunately, with age and use, these nylon clips can wear out, and the female slider can distort, which results in a fairly noticeable amount of play. The steering wheel can be rotated a few degrees before the slop is taken up and the rotational motion continues downstream to the rack.

The male and female slider portions of the steering shaft system (these have been freshly cad-plated), along with the original nylon bushings (the two circular raised spots on each side are almost entirely worn away), and Wilkinson's stamped steel replacements

A better solution, one which retains the functionality of the collapsible column, is to replace the nylon clips with new ones from stamped steel. Panteras by Wilkinson sells these replacement clips, and although they are rather expensive at about \$15 each, they are highly effective. In practice, they are quite a bit too large to enable the two halves to fit easily together, which is a good thing. Once the clips are installed, the male slider has to be hammered into the female half (using a plastic or rubber mallet), which deforms the clips just enough to allow the halves to slide together without allowing any additional freedom of movement.

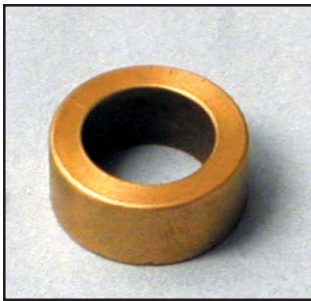
When a steering wheel is overtightened to the point where the spring fully compresses (coil-binds), the whole shaft is drawn up in the tube, and at the bottom the steel washer actually smashes and shatters the nylon bearing, leaving the bottom of the shaft unsupported in the tube. Almost ever Pantera I've ever seen fitted with a non-Momo aftermarket wheel has this problem (the Momo hub appears to be the proper length to keep this from happening).

Dennis Quella has machined a new oillite bearing to replace the often-damaged nylon bushing in the bottom of the tube

Pantera Performance Center has created a replacement bearing, made of the same material as the steering rack bushing. With the tube removed from the car and dismantled, the remnants of the old bearing are driven out, and the new one is then installed. It is a press-fit, and normally needs to be hammered into position using an appropriately-sized socket and extension as the press tool. Test-fit it on the shaft to make sure the shaft passes freely through it, and polish or sand the shaft if required (pay particular attention in the area on either side

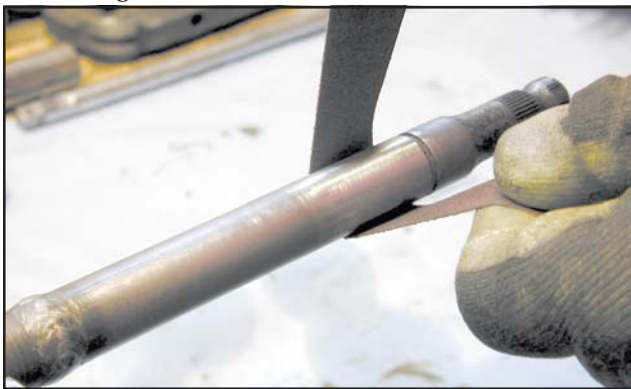
It is important to sand or polish the steering shaft smooth, so the bearing can spin freely upon it

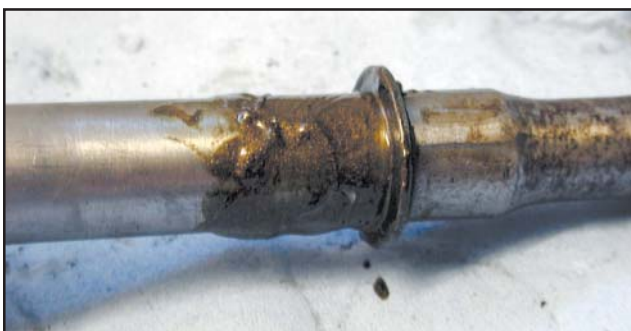
Once the snap ring and washer are installed on the shaft, thoroughly lubricate them with grease or anti-seize

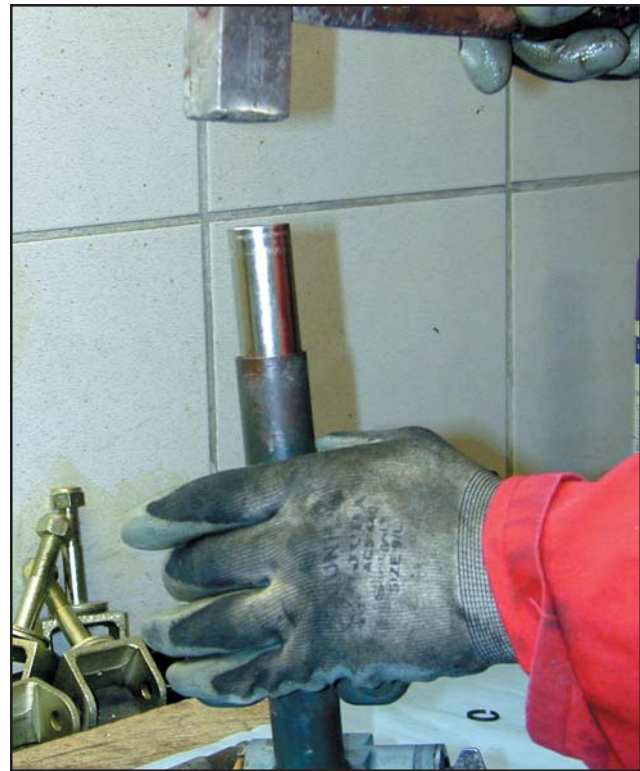
A deep socket is used as the drive tool, to drive the new bearing into the steering column tube until it comes to rest against the stops

of the indentation for the snap ring), then use heavy moly grease when assembling it. This bearing costs only about \$16.

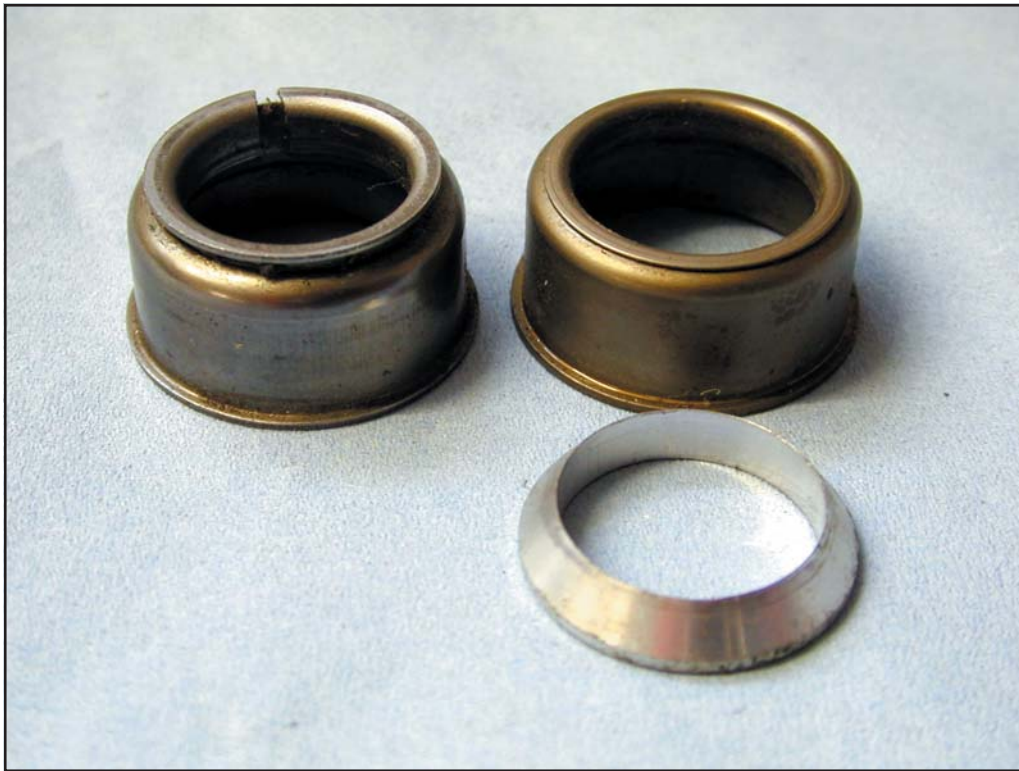
At the top of the steering column tube, the shaft passes through a roller bearing. Inexplicably, the inside diameter of the bearing is 0.770" while the outside diameter of the shaft is 0.745", which means that even if all else is good, there is still noticeable play, with the wheel and column free to move up-and-down and side-to-side. Fortunately, Pantera Performance Center also has an upgrade in the form of a tapered, stepped bushing. This bushing is a tight fit on the steering column (in fact it may need very minor sanding to fit over the column), and its curved profile indexes upon the curved surface of the stock upper bearing, centering it perfectly. In practice, the steering wheel hub, turn signal cam and spring are removed, then the bushing is simply slid down into position, and the removed parts are reinstalled. This now positively locates the steering shaft in the center of the bearing, while allowing the bearing to turn freely. This little gem is only about \$7.

An original steering tube upper bearing on the left, with a new replacement bearing on the right. The machined aluminum centering spacer slides over the top of the steering shaft, and indexes on the curved radius of the bearing, centering the shaft perfectly

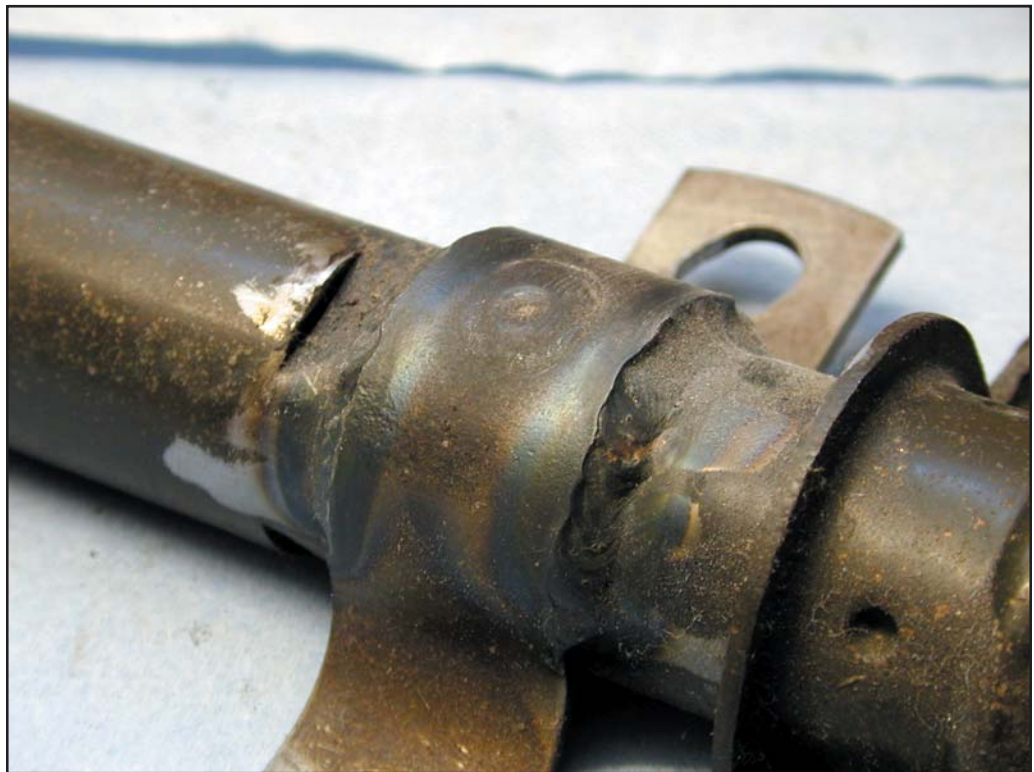
the lower ones pass through a clamp which is held to the tube with a single spot weld. On virtually every Pantera I've seen, that spot weld has broken, which means that the whole steering column is free to move around. The solution is to seam-weld the clamp to the tube. As the clamp is very close to the bottom (nylon) bearing, if you don't remove the bearing first, the heat from welding will melt it, leaving quite a mess on your hands!

The mounting bracket for the steering column tube is held in place with just a single spot-weld in the center of the bracket; on this car, as most cars, this weld was broken. This bracket was seam-welded along its entire length. Note the indentations on the left which locate the bottom bearing. Be sure to fully remove the remnants of the nylon bushing before welding the bracket, or the heat will melt the nearby bushing and make a real mess. (Don't ask me how I know this!)

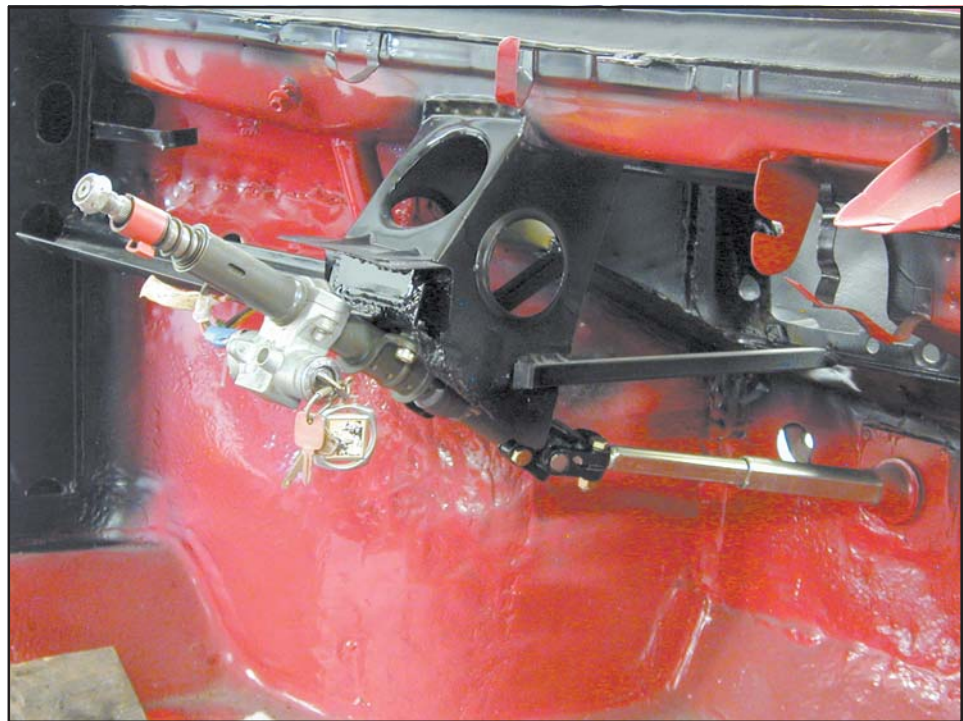
tom, there can be unwanted movement, caused by flexing of the supporting structure. Particularly on early cars, the structure under the dash was notoriously under-engineered, consisting of a poorly supported sheetmetal box. Enormous gains in rigidity can be gained by simply welding a pair of supporting strut braces between the back of the box, and the 'firewall'. Triangulating this structure will make it rock-solid. Of course this is best done with the entire inte-

This photo shows the steering column mounting structure on a very early European pushbutton Pantera, #1256. The sheetmetal box was completely unsupported and very flexible; vigorous driving would see the whole steering column moving around. Note the two reinforcements made using half-inch steel tubing (the second one is visible by looking through the hole on the side of the box). These two tubes made a tremendous improvement in rigidity. Later cars had a sturdier arrangement from the factory, but still benefit greatly from reinforcement

rior removed from the car, but if caution is exercised, it can be done with the car assembled. When routing the struts, ensure that they will clear any components that aren't installed at the time, such as the pedals and pedal support.
