Steering Solutions

Story and Photos by Mike Drew

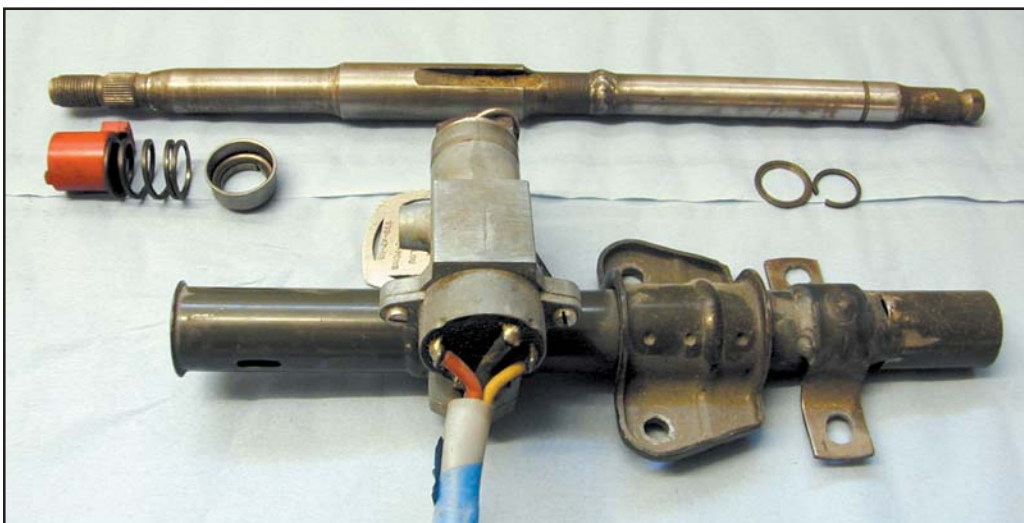
This is the steering column disassembled; the steering wheel would be towards the left in this photo. The turn signal cam, spring, and upper roller bearing are on the left, with the snap ring and washer on the right. Not pictured is the nylon lower bearing, which is inside the tube, retained by the three punched-in portions just to the right of the clamp

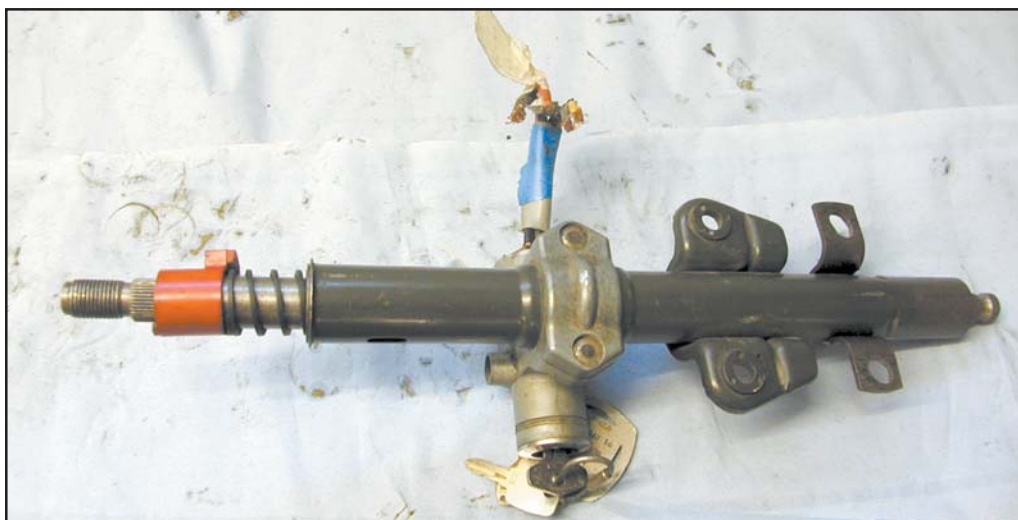
The overhauled and blueprinted steering column, ready for installation in the car
